Solomon Trader Oil Spill

Case Study 1: Solomon Trader Incident
19 October 2021

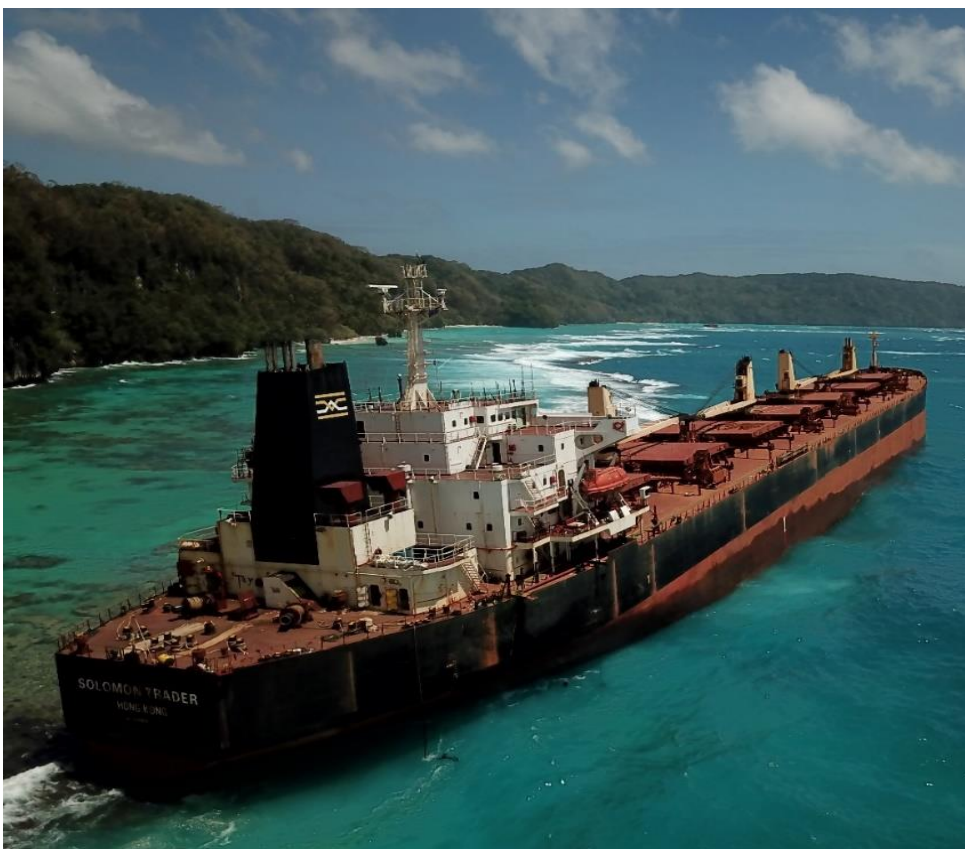
- 5 February 2019.
 - MV Solomon Trader ran aground on a coral reef in Kagava Bay, Rennell Island, Solomon Islands
- 15 February 2019
 - Heavy fuel oil observed leaking from the stern.
- Over 300 tonnes of heavy fuel oil onto the shallow fringing reef
- Salvage and removal of wreck necessary
- An intensive clean-up operation conducted from early March to 26 July 2019.

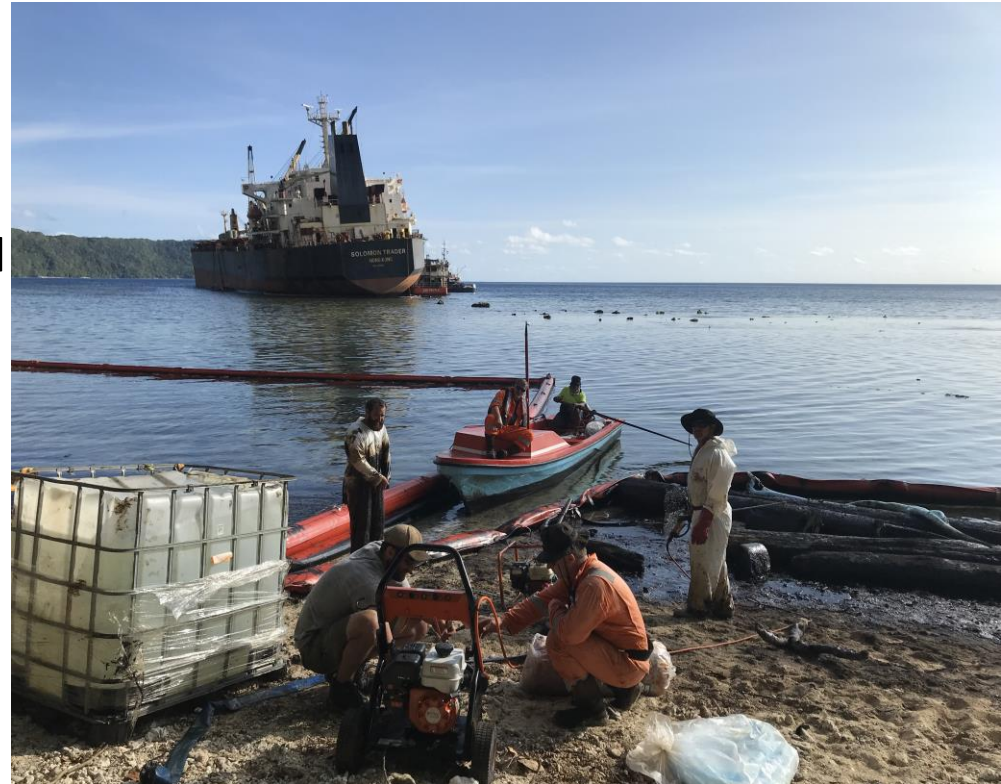
- Preliminary Environment Assessment
- Response
 - Salvage: 11th May 2019 vessel re-floated, 15th June 2019 vessel towed from Solomon Waters
 - Removal of Oil
 - Shoreline Clean-up
 - Offshore Clean-up
- Recovery
 - Environment Damage Assessment by SIG/UNEP/ITOPF/Insurer
